**Subject: Final Preliminary Assessment Report
TVA Homer L Owens Substation Capacitors
EPA Identification No. KY8890090006
EPA Contract No. EP-W-05-054
Technical Direction Document (TDD) No. TTEMI-05-003-0173**

FINAL
PRELIMINARY ASSESSMENT REPORT

TVA HOMER L OWENS SUBSTATION CAPACITORS
RUSSELLVILLE, LOGAN COUNTY, KENTUCKY

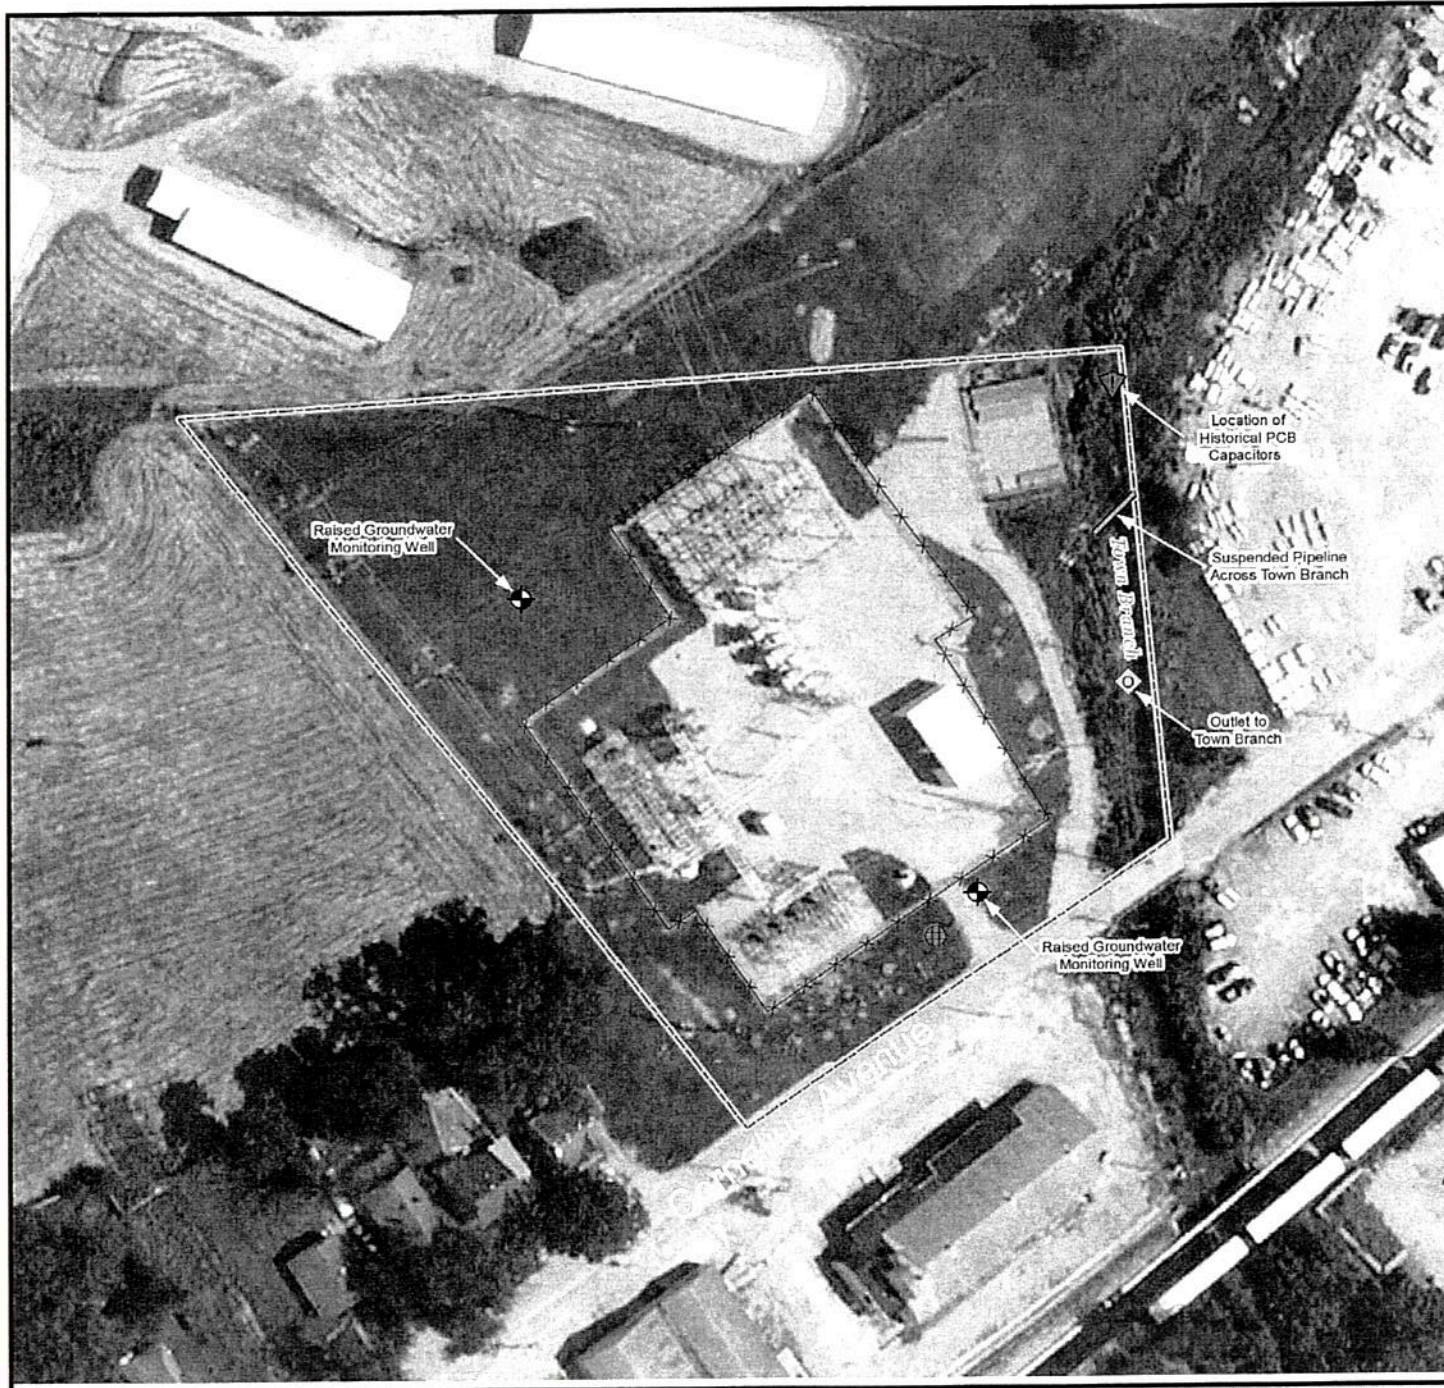
The site is an approximate 1,475-square-foot parcel located along Cornelius Avenue in Russellville, Logan County, Kentucky (see Figures 1 and 2 in Appendix A). More specifically, the geographic coordinates for the TVA substation property, as measured from the entrance on Cornelius Avenue, are 36.848299 degrees north latitude and 86.891126 degrees west longitude. The parcel identification number from the Logan County geographic information system is "068-01-04-031-00" (Reference [Ref.] 1). The TVA substation property is bordered to the north by commercial properties, to the east by commercial and industrial properties, to the south by Cornelius Avenue with commercial properties beyond, and to the west by residential properties with commercial properties. Town Branch transects the eastern portion of the TVA substation property (see Figure 2 in Appendix A).

The nearest residents are located about 330 feet west of the TVA substation (see Figure 2 in Appendix A). The nearest school is about 0.48 mile to the southeast (Ref. 16). About 3,976 people live within 1 radial mile, and about 9,991 people live within 4 radial miles of the TVA substation. Based on the U.S. Bureau of the Census 2010 population data, the residential population within a 4-mile radius is distributed as follows: >0 to 0.25 mile, 248 persons; >0.25 to 0.50 mile, 669 persons; >0.50 to 1.0 mile, 3,059 persons; >1.0 to 2.0 miles, 3,101 persons; >2.0 to 3.0 miles, 1,555 persons; >3.0 to 4.0 miles, 1,359 persons (Ref. 17) (see Figure 3 in Appendix A).

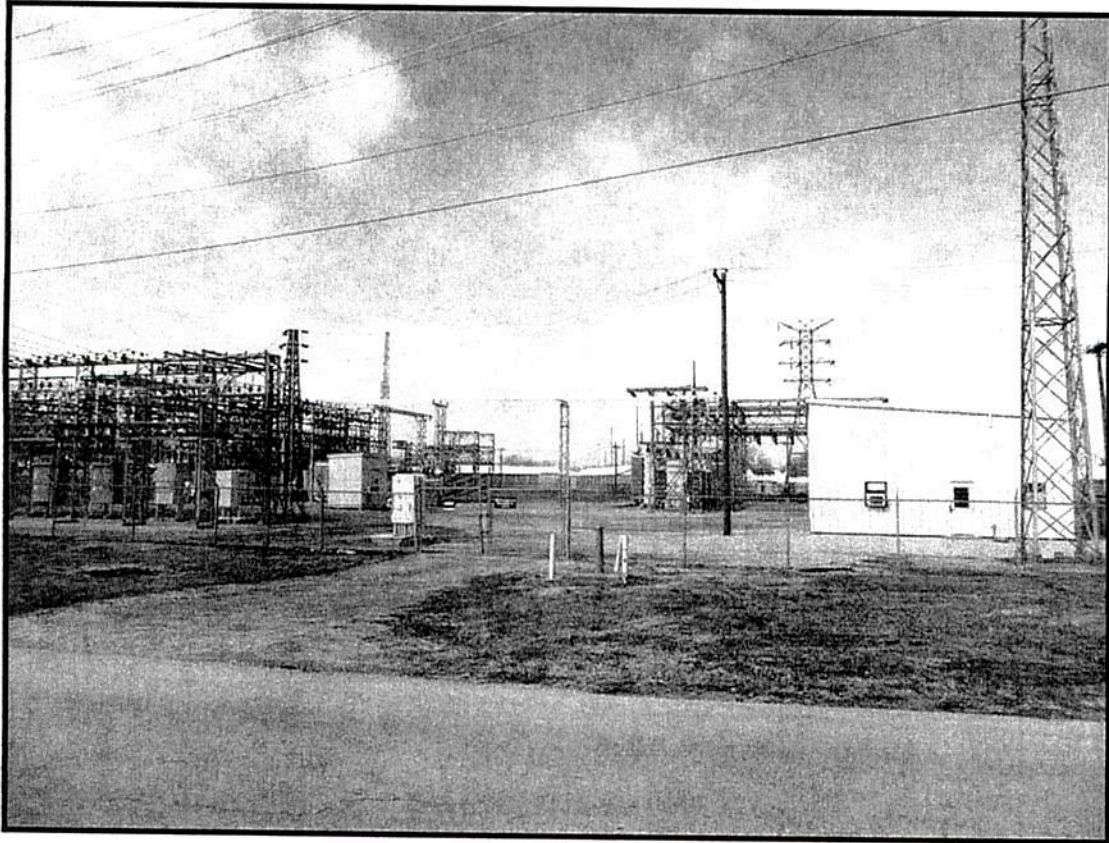
OFFICIAL PHOTOGRAPH NO. 1
U.S. ENVIRONMENTAL PROTECTION AGENCY

TDD Number:	TTEMI-05-003-0173	Location:	TVA Homer L Owens Substation Capacitors
Orientation:	Northwest	Date:	December 20, 2013
Photographer:	Sherry Weedman, Tetra Tech	Witness:	None
Subject:	View of the front entrance and gate to the Tennessee Valley Authority (TVA) Homer L Owens Substation Capacitors (the TVA substation).

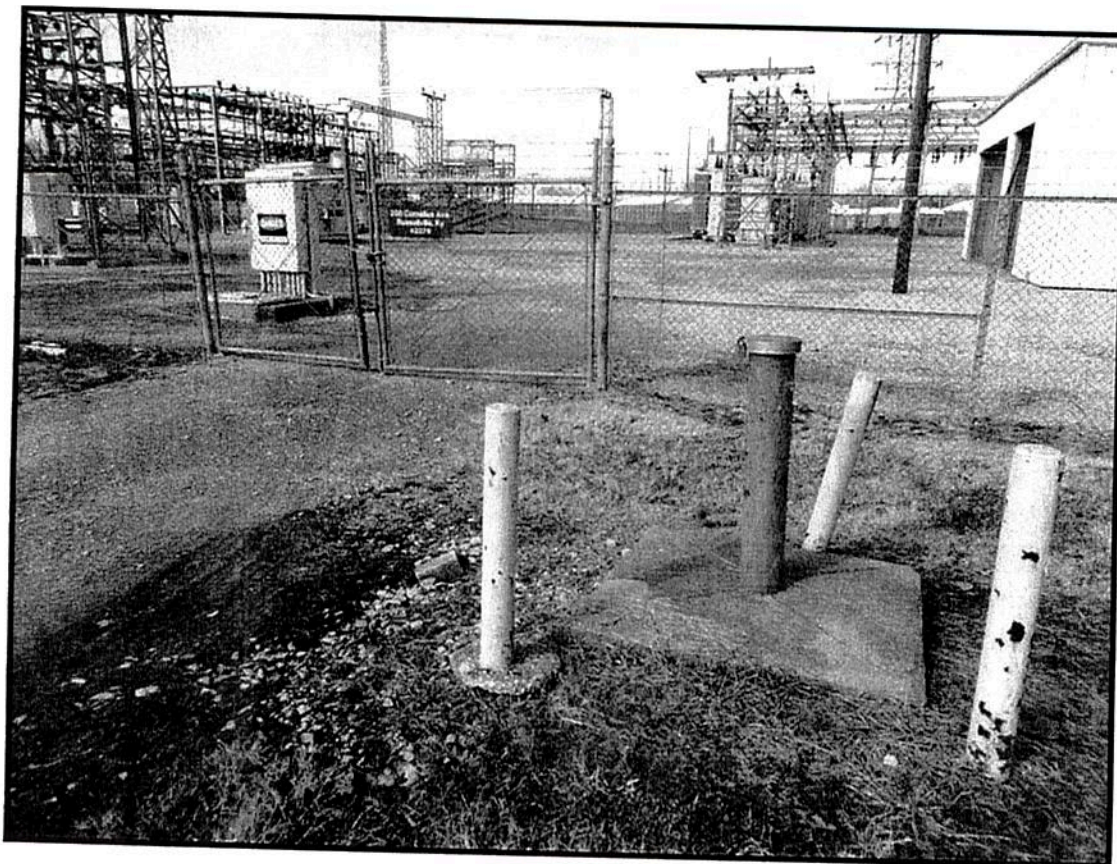
OFFICIAL PHOTOGRAPH NO. 2
U.S. ENVIRONMENTAL PROTECTION AGENCY

TDD Number: TTEMI-05-003-0173 Location: TVA Homer L Owens Substation
Capacitors
Orientation: Northwest Date: December 20, 2013
Photographer: Sherry Weedman, Tetra Tech Witness: None
Subject: View of the front entrance and sign to the TVA substation. A monitoring well is
visible in the foreground.

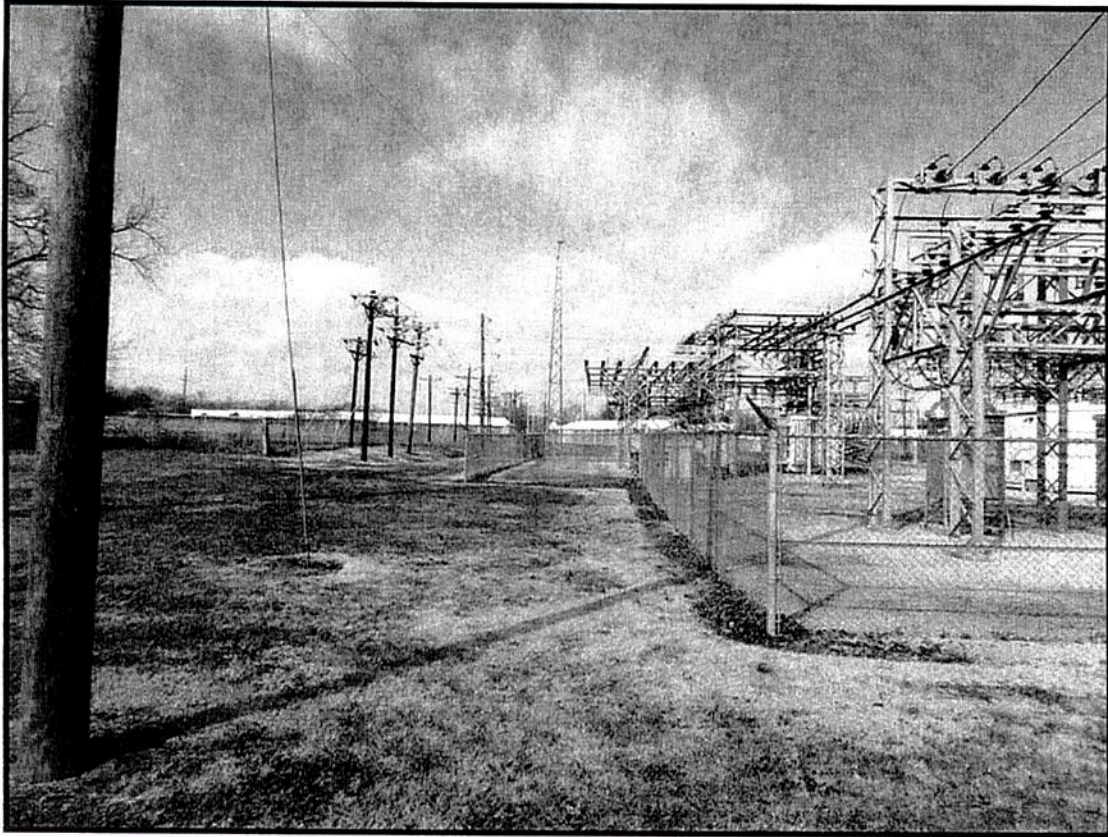
**OFFICIAL PHOTOGRAPH NO. 3
U.S. ENVIRONMENTAL PROTECTION AGENCY**

TDD Number:	TTEMI-05-003-0173	Location:	TVA Homer L Owens Substation Capacitors
Orientation:	Northwest	Date:	December 20, 2013
Photographer:	Sherry Weedman, Tetra Tech	Witness:	None
Subject:	View of the western portion of the TVA substation. The substation structures are fenced.

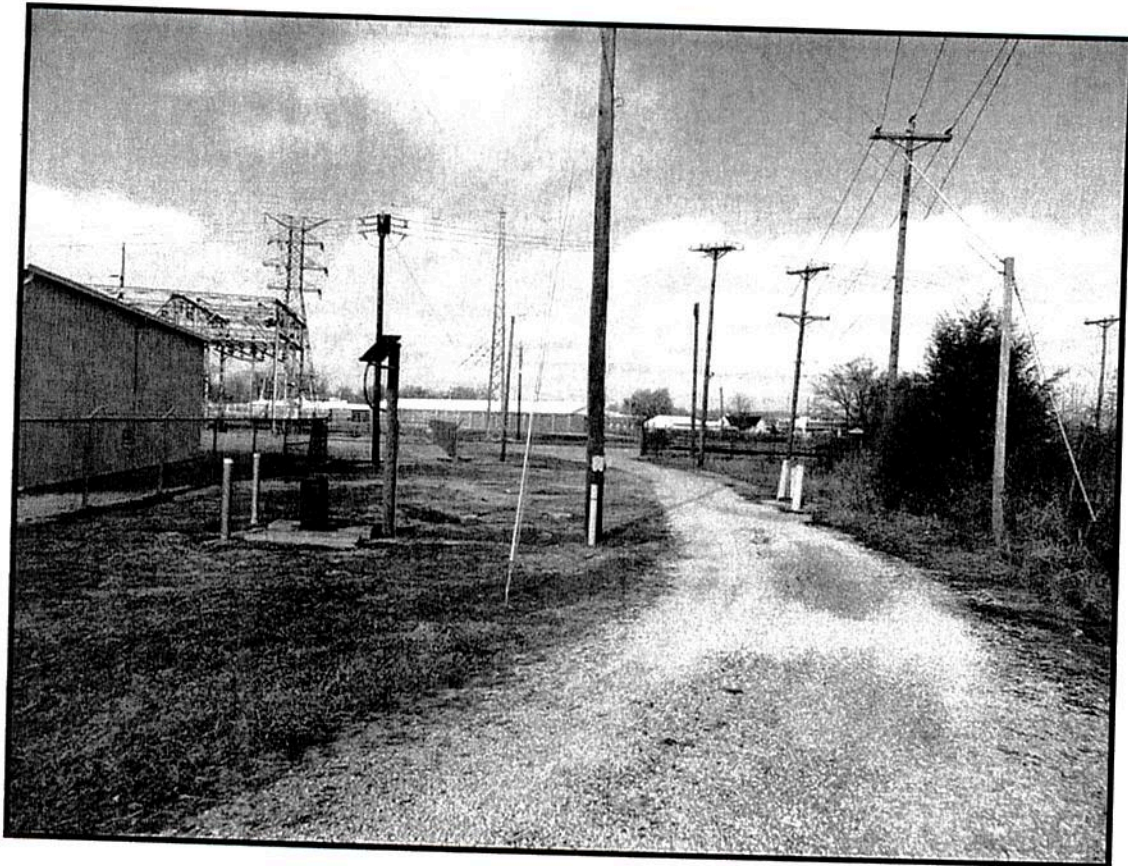
OFFICIAL PHOTOGRAPH NO. 4
U.S. ENVIRONMENTAL PROTECTION AGENCY

TDD Number:	TTEMI-05-003-0173	Location:	TVA Homer L Owens Substation Capacitors
Orientation:	North	Date:	December 20, 2013
Photographer:	Sherry Weedman, Tetra Tech	Witness:	None
Subject:	View of the eastern portion of the TVA substation. The substation structures are fenced.

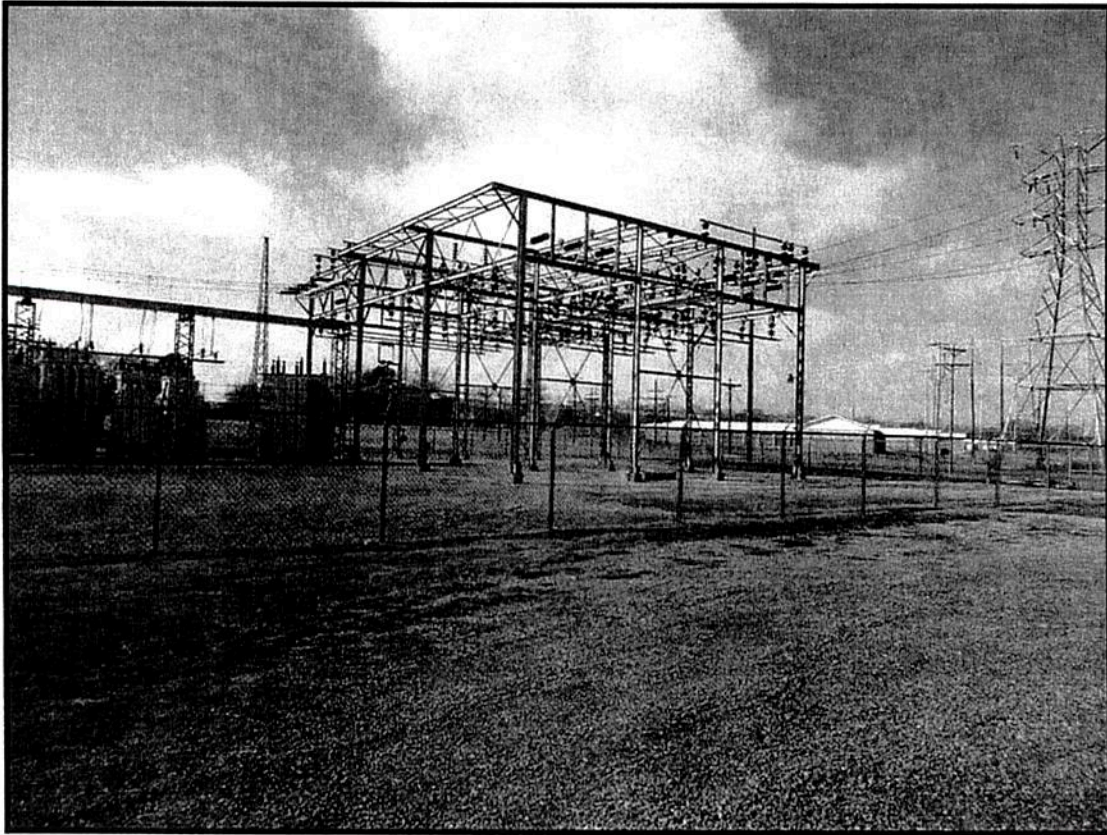
OFFICIAL PHOTOGRAPH NO. 5
U.S. ENVIRONMENTAL PROTECTION AGENCY

TDD Number:	TTEMI-05-003-0173	Location:	TVA Homer L Owens Substation Capacitors
Orientation:	Northwest	Date:	December 20, 2013
Photographer:	Sherry Weedman, Tetra Tech	Witness:	None
Subject:	View of the northern portion of the TVA substation. The substation structures are fenced.

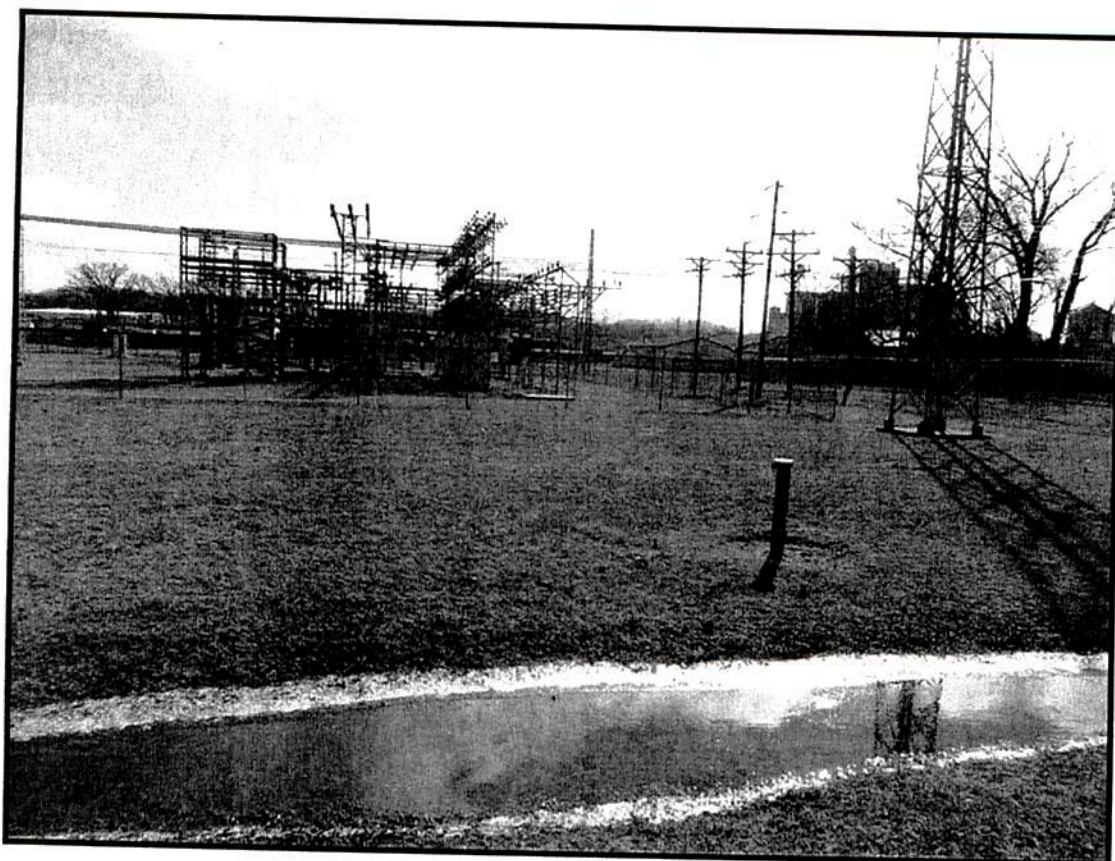
OFFICIAL PHOTOGRAPH NO. 6
U.S. ENVIRONMENTAL PROTECTION AGENCY

Subject: View of the northern portion of the TVA substation. The substation structures are fenced. A monitoring well is visible in the foreground. A low lying earthen area is also visible in the foreground. At the time of the site reconnaissance, the area contained approximately four inches of standing water and was approximately twenty feet in length.

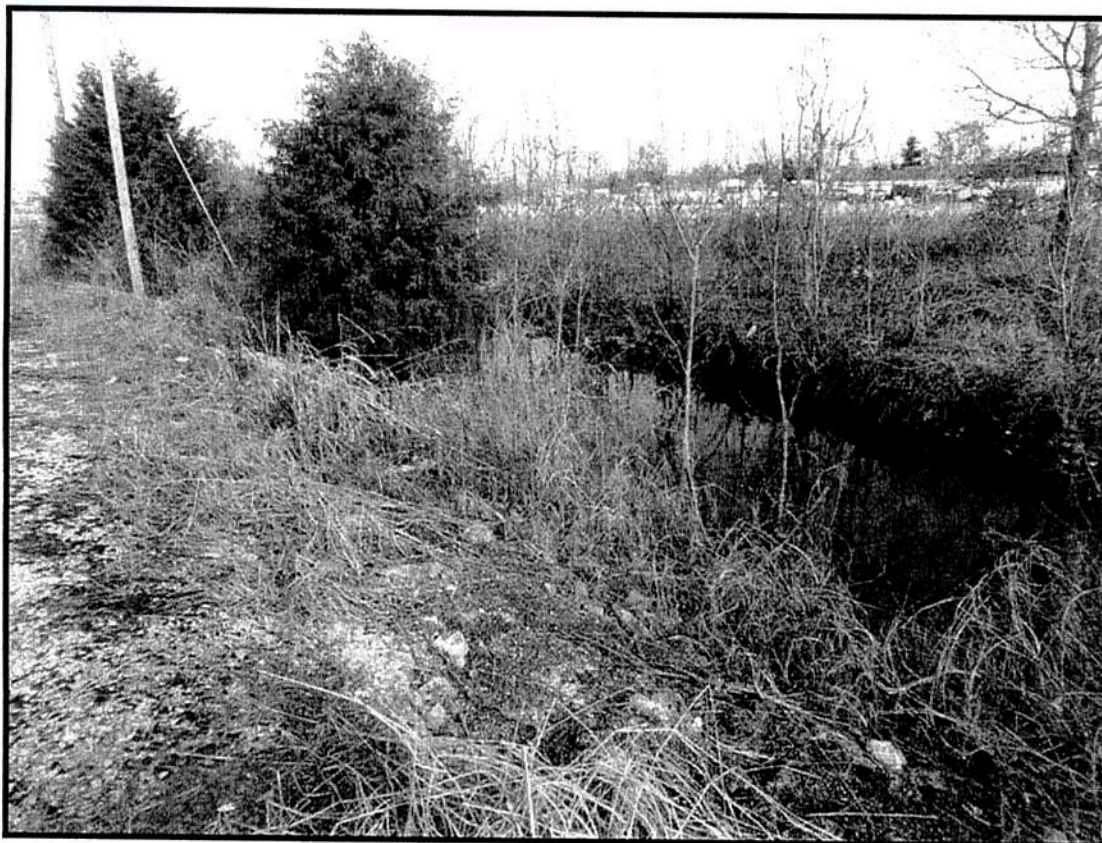
OFFICIAL PHOTOGRAPH NO. 7
U.S. ENVIRONMENTAL PROTECTION AGENCY

On December 20, 2013, Tetra Tech conducted a site reconnaissance in the vicinity of the TVA substation. Town Branch appeared to have undergone remedial activities, as riprap was observed along both the west and east banks (see photograph 7 in Appendix B). An outlet pipe from a storm water drain located adjacent to the substation structures was observed on the west bank of Town Branch located in the eastern portion of the TVA property. Water was not observed discharging from the outlet pipe at the time of the site reconnaissance. A pipeline of unknown origin suspended above the water was leading from the west bank to the east bank of Town Branch. Two monitoring wells were observed on the TVA substation property. No obvious signs of soil staining, discoloration, or odors were observed at the TVA substation or in Town Branch during the site reconnaissance. No fish were observed in Town Branch in the vicinity of the TVA substation. (Ref. 6; see Figure 2 in Appendix A).

TDD Number:	TTEMI-05-003-0173	Location:	TVA Homer L Owens Substation Capacitors
Orientation:	North	Date:	December 20, 2013
Photographer:	Sherry Weedman, Tetra Tech	Witness:	None
Subject:	View of the west bank of Town Branch, located along the eastern property boundary of the TVA substation. Riprap is visible along the west bank.

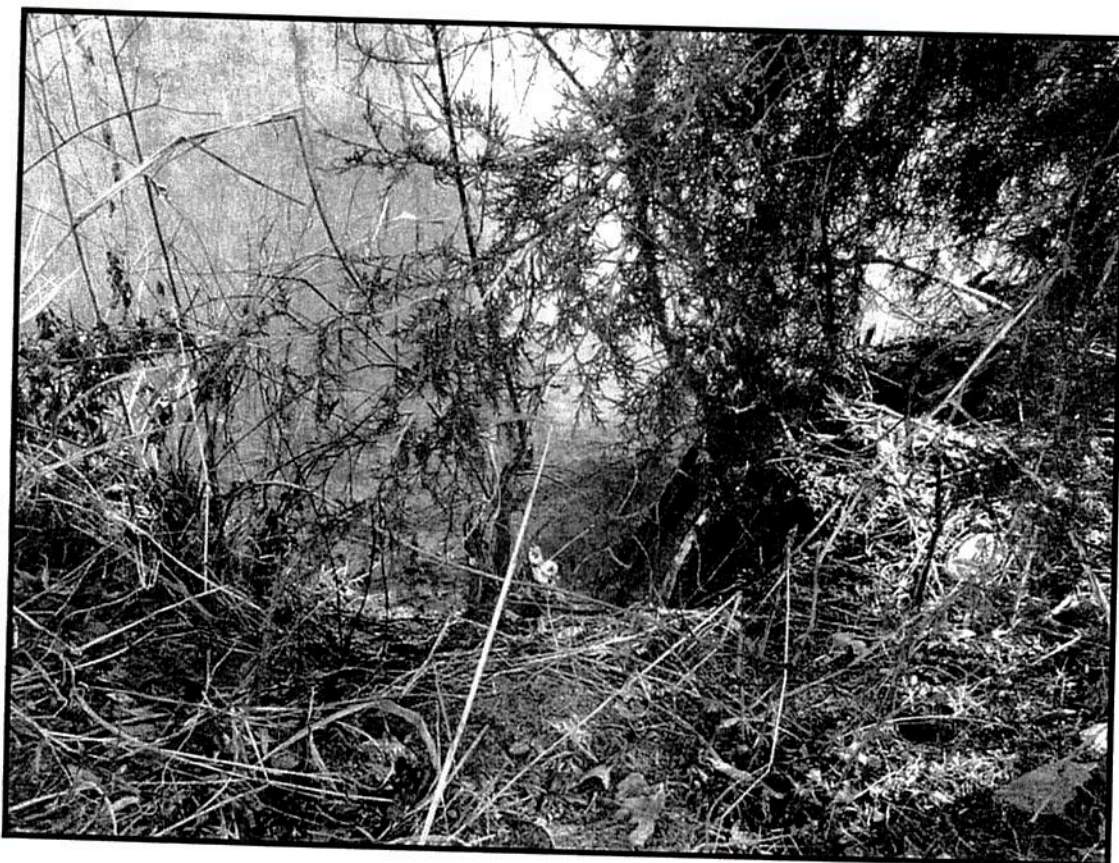
OFFICIAL PHOTOGRAPH NO. 8
U.S. ENVIRONMENTAL PROTECTION AGENCY

TDD Number:	TTEMI-05-003-0173	Location:	TVA Homer L Owens Substation Capacitors
Orientation:	East	Date:	December 20, 2013
Photographer:	Sherry Weedman, Tetra Tech	Witness:	None
Subject:	View of an outlet pipe from a storm water drain located adjacent to the TVA substation structures on the west bank of Town Branch.

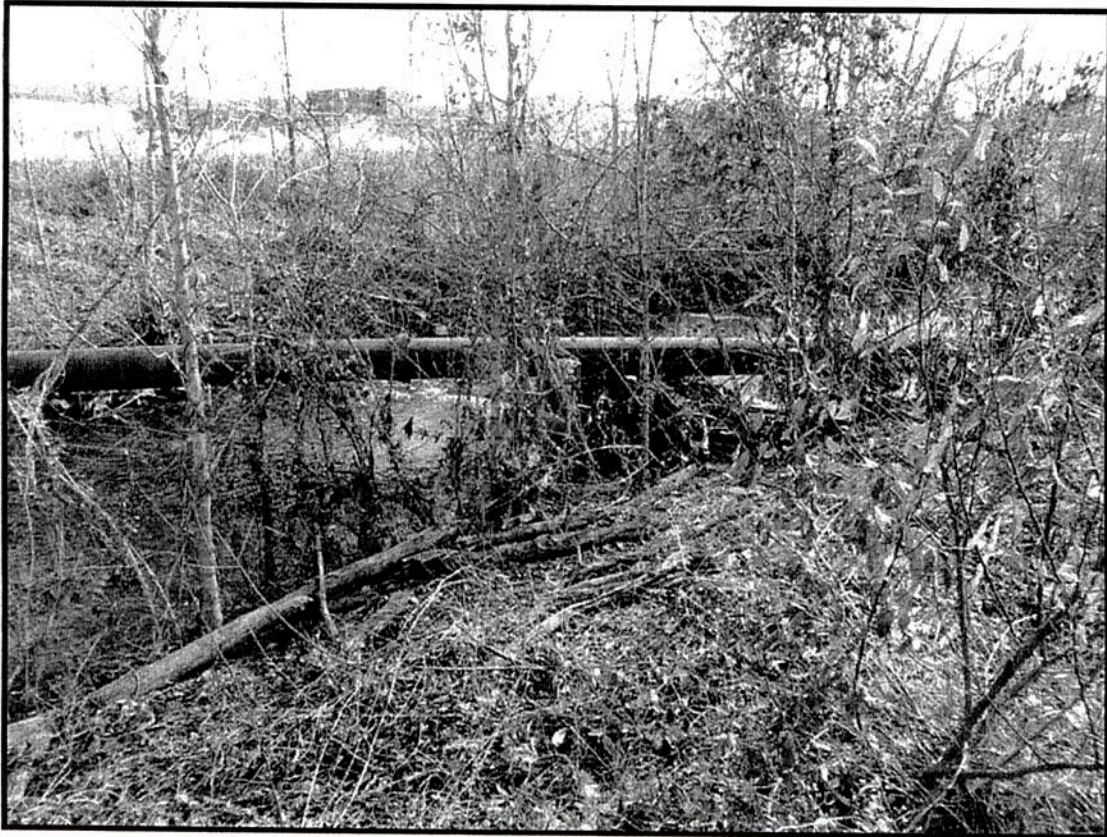
OFFICIAL PHOTOGRAPH NO. 9
U.S. ENVIRONMENTAL PROTECTION AGENCY

Town Branch is a small creek that runs north through the city of Russellville and is located to the south and east of the former Rockwell Automation, Inc. (Rockwell) facility. The former Rockwell facility is located approximately 0.25 mile west of the TVA substation property (Ref. 2, p. 8; see Figure 1 in Appendix A). The East Ditch and the North Ditch located at the former Rockwell facility discharge into Town Branch (Refs. 2, p. 8; 3, p. 4). During the Tetra Tech site reconnaissance, flowing water was visible in Town Branch (see photograph 9 in Appendix B).

TDD Number:	TTEMI-05-003-0173	Location:	TVA Homer L Owens Substation Capacitors
Orientation:	Southeast	Date:	December 20, 2013
Photographer:	Sherry Weedman, Tetra Tech	Witness:	None
Subject:	View of a pipeline of unknown origin leading from the west bank to the east bank of Town Branch.

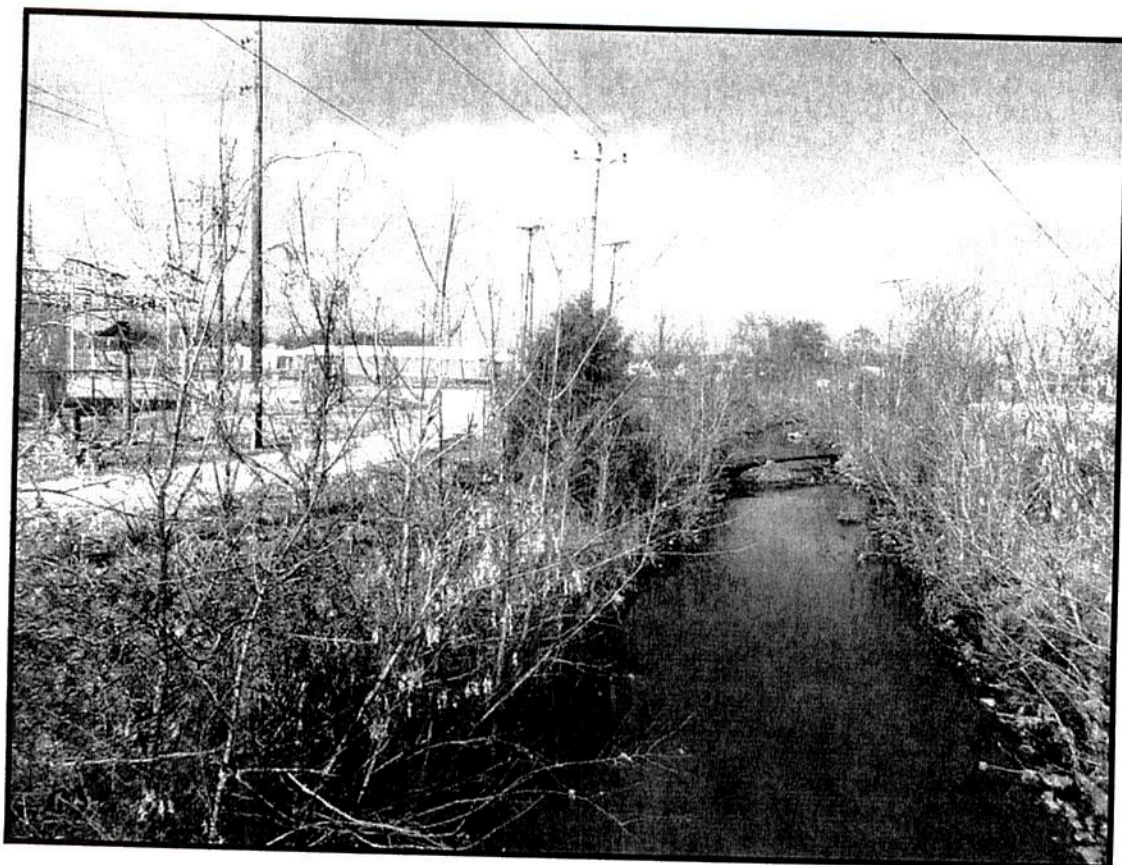
OFFICIAL PHOTOGRAPH NO. 10
U.S. ENVIRONMENTAL PROTECTION AGENCY

TDD Number:	TTEMI-05-003-0173	Location:	TVA Homer L Owens Substation Capacitors
Orientation:	North	Date:	December 20, 2013
Photographer:	Sherry Weedman, Tetra Tech	Witness:	None
Subject:	View of Town Branch from the Cornelius Avenue Bridge located directly southeast and upstream of the TVA substation. The substation structures are visible to the left. The pipeline of unknown origin crossing Town Branch is visible in the background.
